TIMBERWRAP

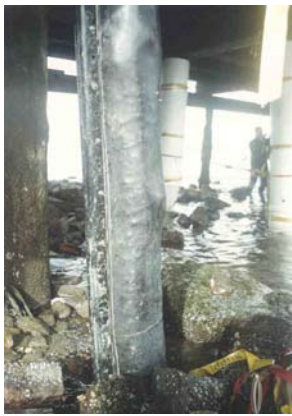
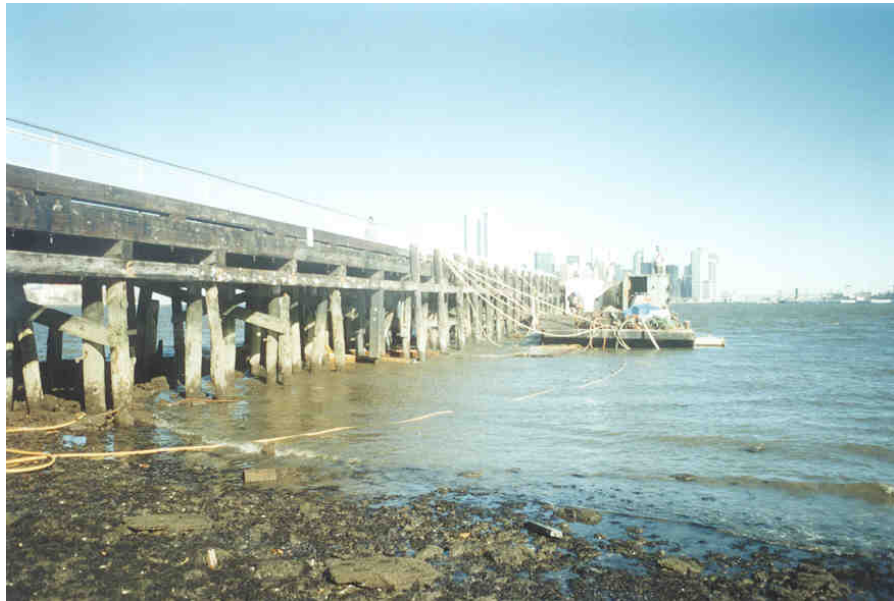
In response to this challenge, CCI has developed the **Timberwrap**, which is a highly elastomeric, easily installed, one-piece adjustable jacket which is stretched around the pile and secured via a full length closure flange closely following the irregular pile contours, which virtually eliminates entrapped water and prevents "water pumping action" under the wrap. Time release additives inside the jacket ensure the elimination of the borer activity, while remaining environmentally friendly to both the installers and the surrounding marine life. **Timberwrap's** unique closure system also provides the facility for easy removal and replacement at intervals throughout the service life to facilitate pile surface inspection.
